Built for Foul Weather

A new home on the Oregon coast blends reclaimed materials with durable details

BY NATHAN GOOD

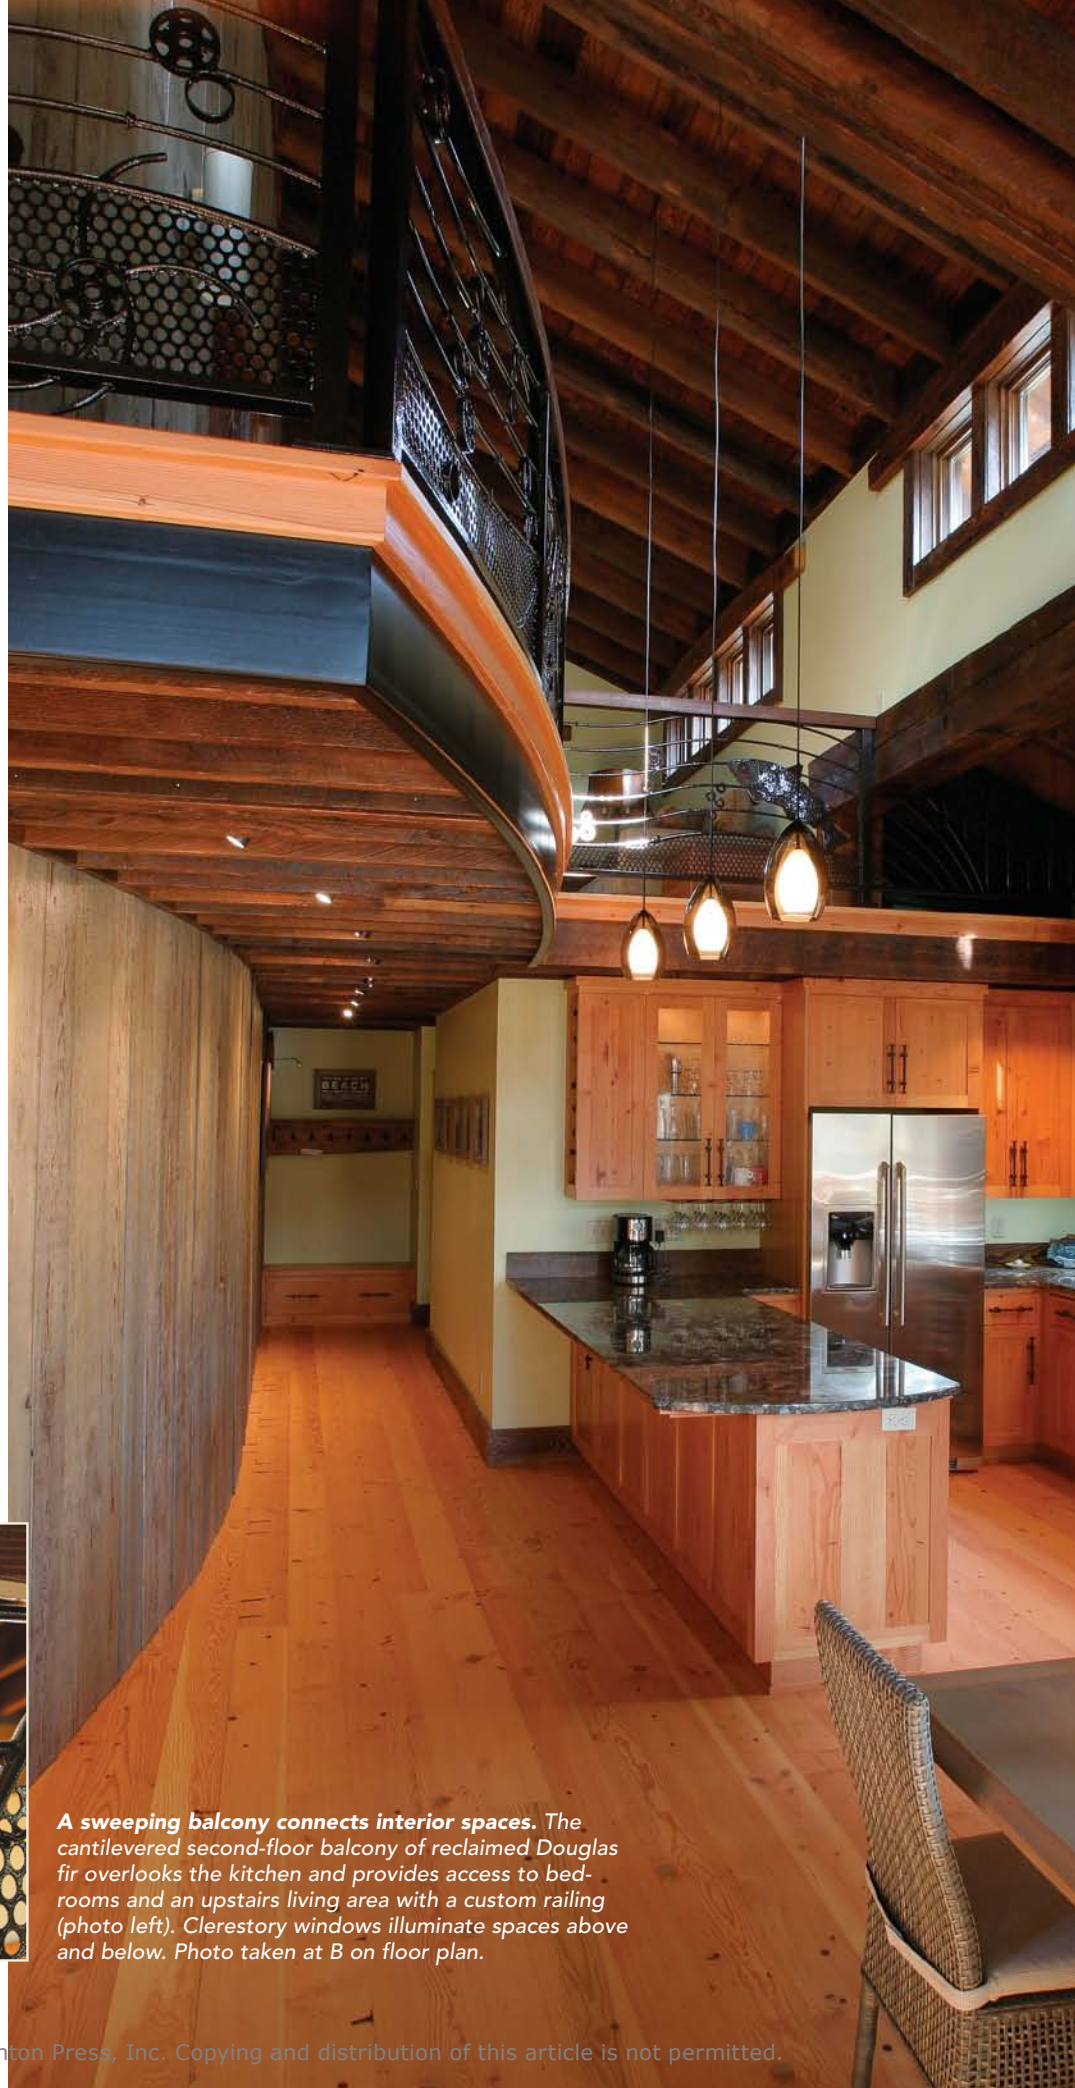
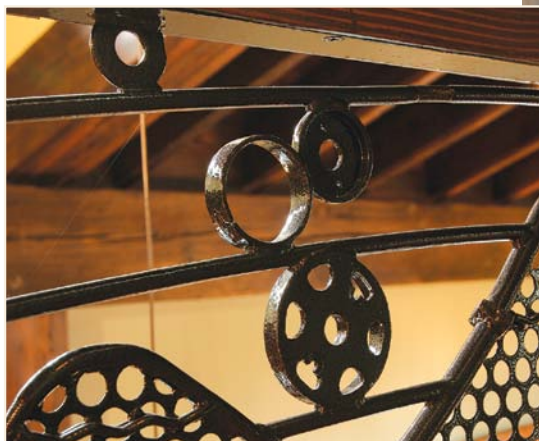
A sweeping balcony connects interior spaces. The cantilevered second-floor balcony of reclaimed Douglas fir overlooks the kitchen and provides access to bedrooms and an upstairs living area with a custom railing (photo left). Clerestory windows illuminate spaces above and below. Photo taken at B on floor plan.

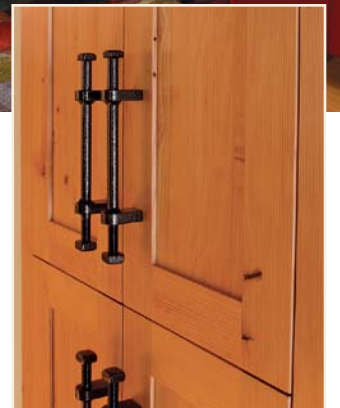
A great room with fine details. Flooded with daylight, the living room is anchored by a chimney made of locally quarried stone. Reclaimed Douglas fir was used as framing, flooring, trim, and shelving, and as material for the built-in cabinets. Old bolts were powder-coated and used as cabinet hardware. Photo taken at C on floor plan.

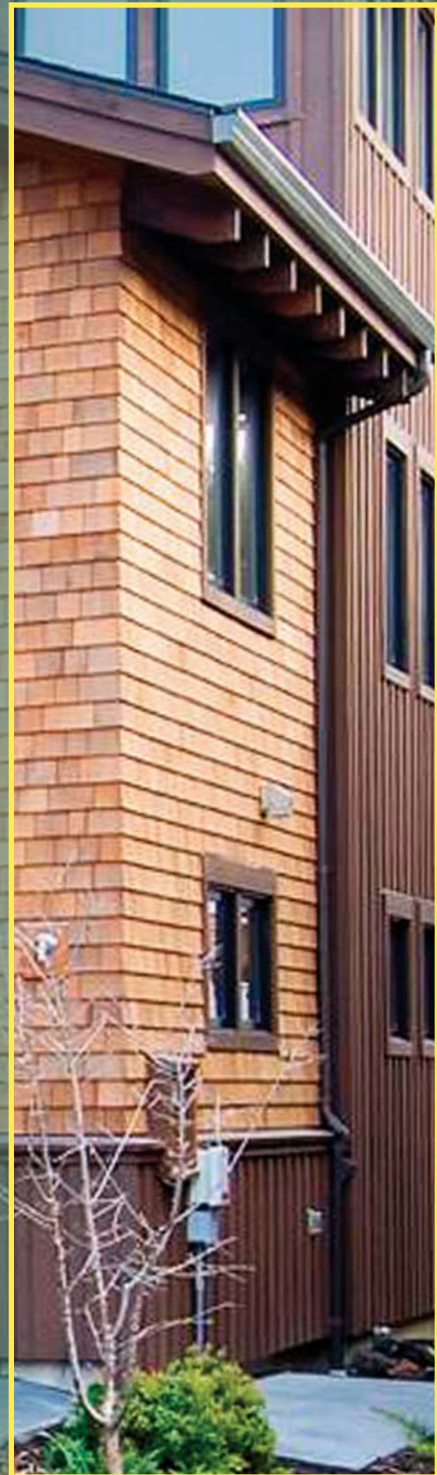
DURABILITY IS IN THE DETAILS

The west wall of this house, which is buffered from the open ocean by only a few other houses and a few trees, is highly susceptible to storm damage.

Constructed with reinforced concrete, the wall is built to withstand the wind, weather, and tsunamis of the Pacific Northwest. This wall assembly exemplifies a construction strategy worth considering wherever you plan to build a durable, long-lasting home.

Photo taken at D on floor plan.
